## Cable Connector Gender

**AFFECTED: SD4D, SD4W, SD4C  
As well as their Reseller Designation versions**

## FIELD SERVICE MEMO #30

**Issue Date  
April 24, 2015**

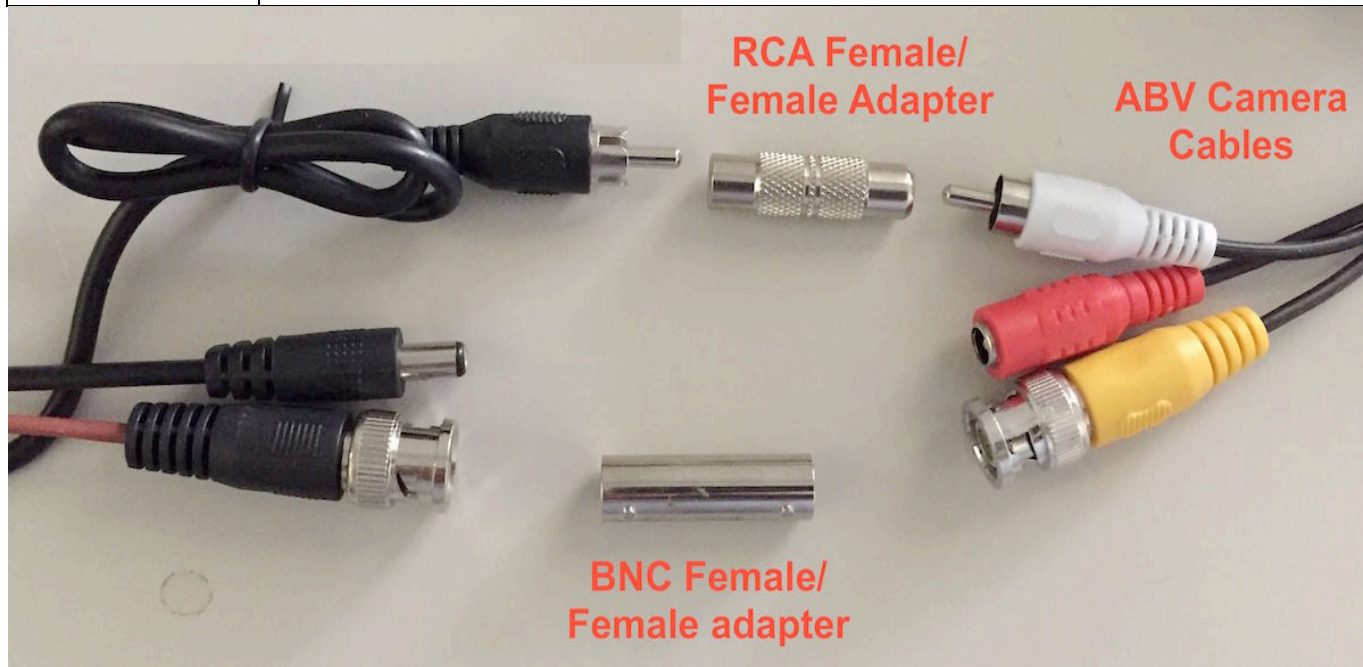
<b>Topic</b>	Short production run shipped with incorrect cable gender
<b>Problem</b>	Some DVRs were shipped with incorrect cable adapter
<b>Complaint</b>	DVR to Camera cable had wrong gender on BNC (Video) and RCA Audio cable connectors.
<b>Manufacturer Notice</b>	On 20150424 ABV was notified of the problem by a customer in MI, and when verified, we notified the manufacturer of the problem so they could correct the problem at the source.
<b>Manufacturer Action Taken</b>	We have been informed by the manufacture that the problem will be corrected in all future production runs for ABV.
<b>ABV Actions Required To Correct Cable Gender</b>	We have created this Service Memo to post online for those who may have received these DVRs from a third party like a reseller who may not have advised them of this service issue. Orders shipped from ABV in the last 60 days will be followed up and those customers who received the order will receive replacement cables or connector gender reversal couplers at no cost.
